# Impact Assessment of Exploratory Wells Offshore South Florida

Eugene A. Shinn  
Barbara H. Lidz  
U.S. Geological Survey  
Fisher Island Station  
Miami, Florida

New Orleans  
January 1990

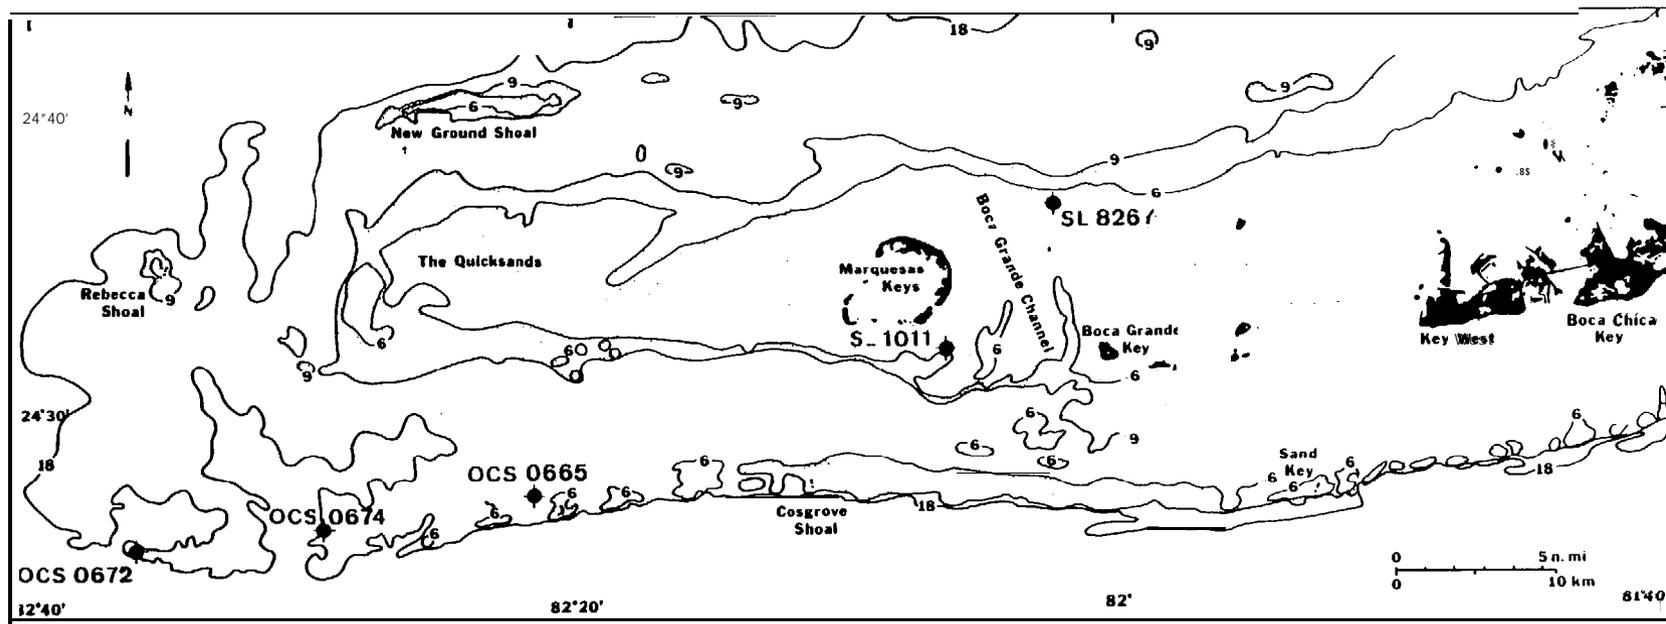
Figure 1. Bathymetric map of Marquesas Keys and reef tract area west of Key West, Florida, showing locations of wells drilled between 1959 and 1962. SL 1011 represents two wells drilled adjacent to each other 2 km (1.2 mi) southeast of the Marquesas and SL 826Y was a single well drilled 7 km (4.3 mi) northeast of the Marquesas. Site OCS 0665 was drilled from a jackup rig drilled 7 km (4.3 mi) northeast of the Marquesas. OCS 0674 was drilled on sandy bottom in 23 m (75 ft) of water, whereas OCS 0672, a few kilometers to the west, was drilled atop a coral knoll in 20 m (65 ft) of water. Contours in meters.

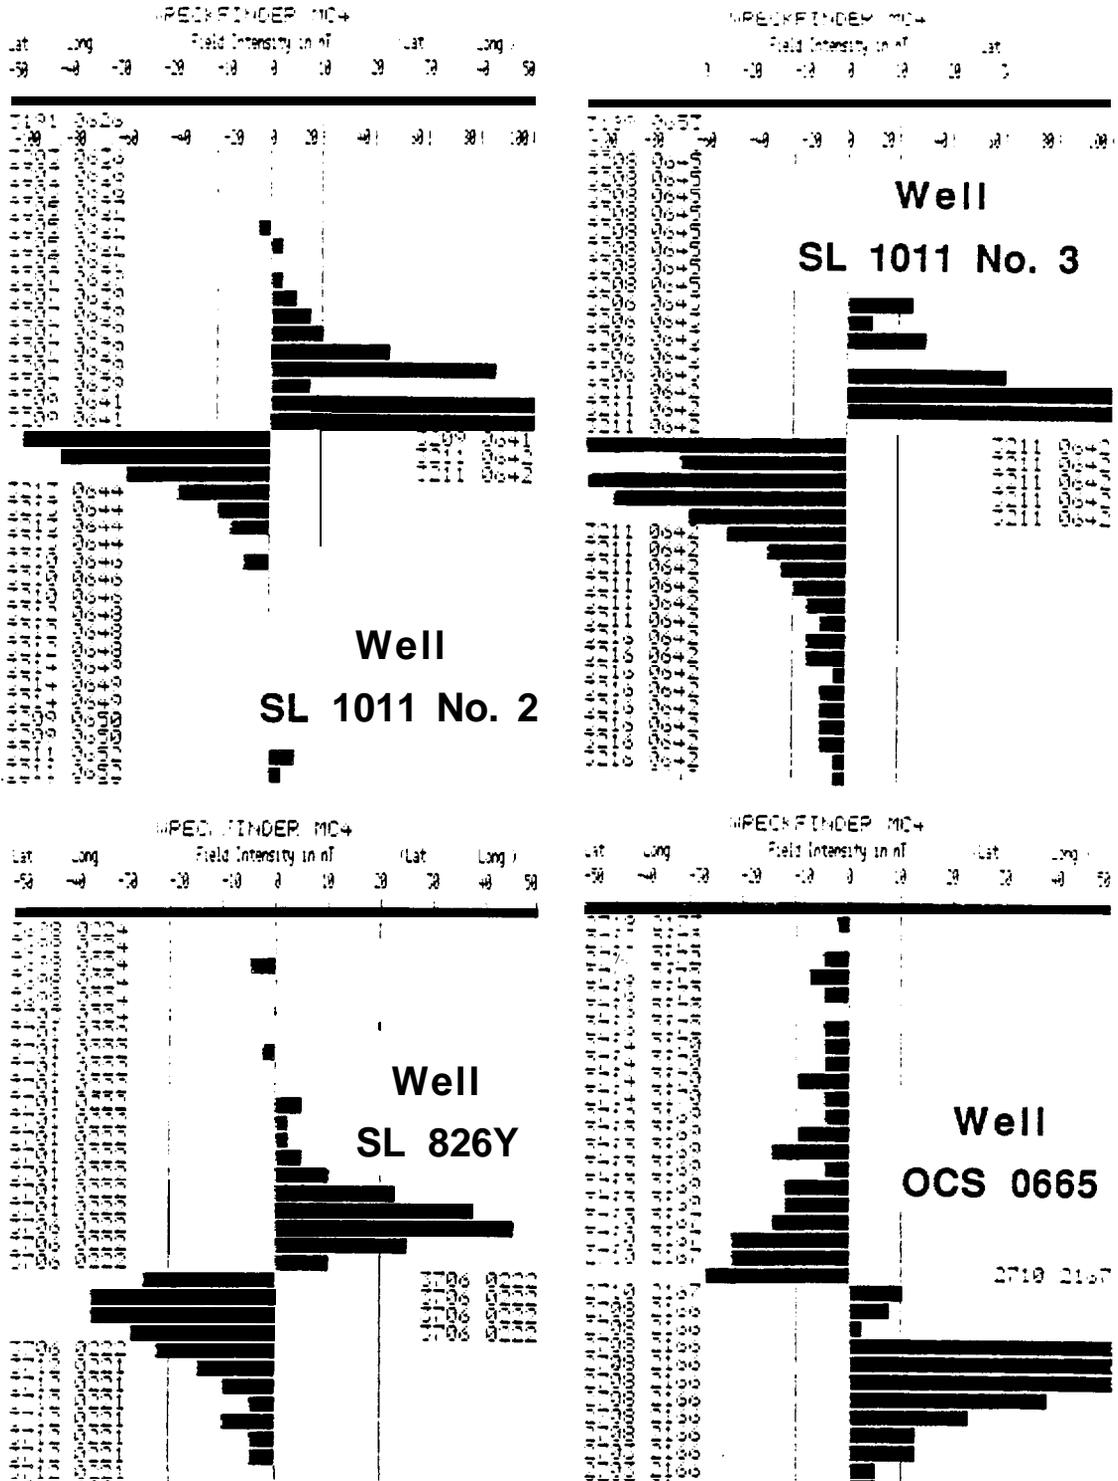
Figure 2. Typical examples of magnetic anomaly printouts from old well sites. Several hundred meters of iron casing, which was left in the earth (not visible at the surface), produces the large anomaly. Printout is calibrated in **nannoteslas**. Well bore is located closest to the point where anomaly printout shifts from negative (left) to positive (right). Latitude and longitude from Loran C navigation unit are printed next to each reading.

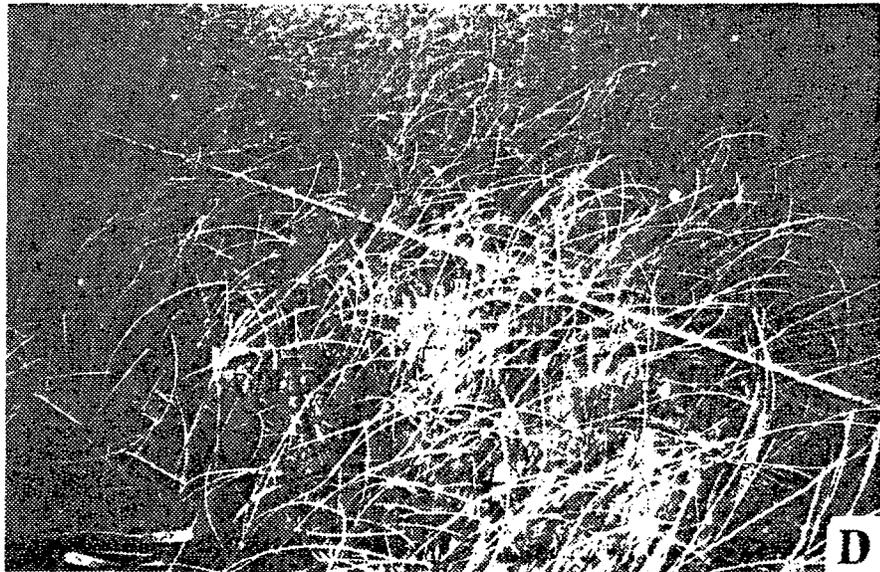
Figure 4 (continued). (C) Fleshy macroalgae *Laurencia* spp. covering peagravel area surrounding cement-bag pile. Photographs taken before the *Diadema* spp. urchin die-off in 1983 show this area was relatively barren of algae. Ten-cm-long tall handle near center provides scale, (D) *Syringodium* spp. and *Thalassia* spp. grass zone as seen along radial-transect line away from cement-bag pile. Substrate here is mostly natural sediment with an admixture of pea gravel. See Figure 5 for distribution of communities.

A fleshy algal community dominated the pea-gravel pile substrate surrounding the cement bag pile. Similar species of algae, but in lesser numbers, were observed growing attached to the bedrock in the natural hard substrate gorgonian community. No sea grasses were observed

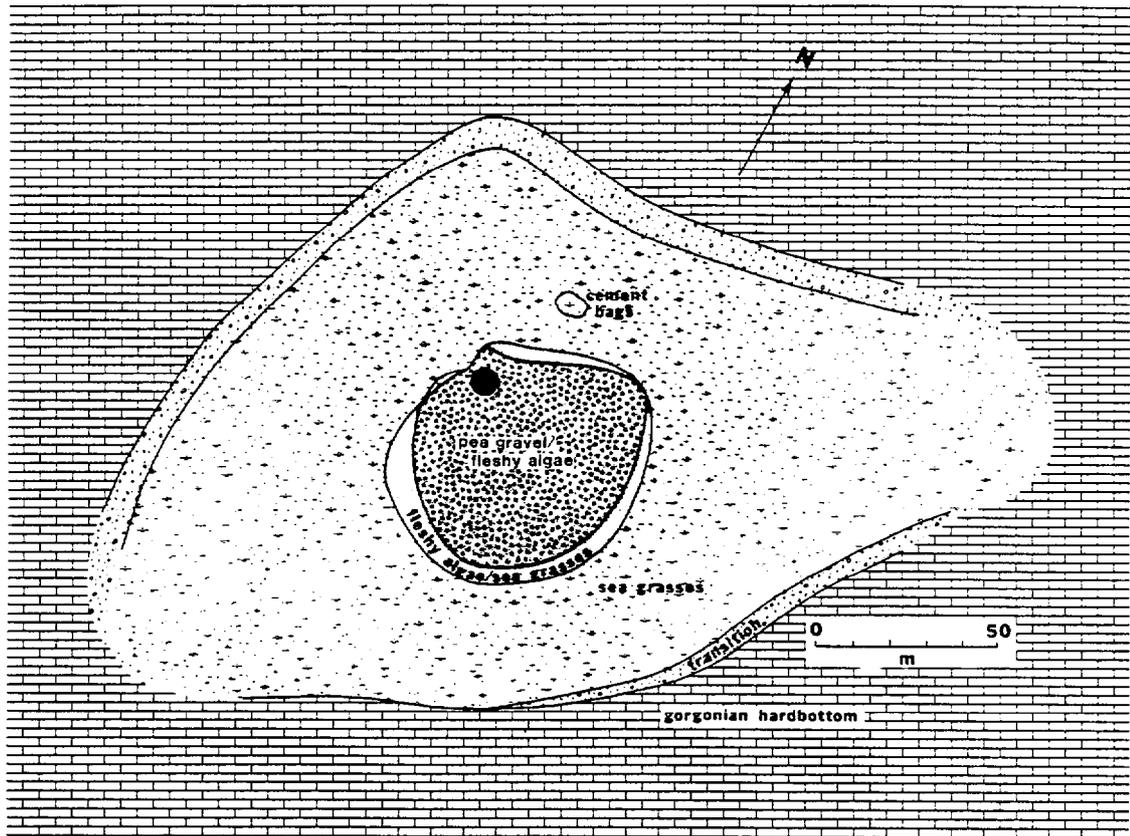
Figure 5. Map of biological communities based on eight transects radiating from main cement-bag (>1 00) pile, which is represented as large black dot. A smaller pile consisting of 8 to 10 bags is located to the northeast of main pile. Location of radial lines is shown in Figure 6A. Well SL 1011 No. 3 is thought to be under main cement-bag pile, whereas well SL 1011 No. 2 is under pea-gravel pile to south of No. 3. Area is surrounded by mostly exposed Pleistocene bedrock populated by **gorgonians**, sponges, and scattered corals. Turtle grasses grow in local sediment-filled depressions throughout the area.

An “ecological halo” was observed at the edge of the cement bag community: a thinning of the vegetation, presumably from grazers which range out from the bag pile to forage. Such halos are common features of tropical patch-reef environments (Randall 1961), and the presence of a halo supports the suggestion that the pile of hardened cement bags serves as an “artificial reef.” We also observed a “reverse ecological halo,” or transition zone, at the edge of the gorgonian **hardbottom** community, suggesting that members of the **hardbottom** community forage into the edges of the seagrass community. Observation and underwater photographs taken prior to the Caribbean-wide die-off of the herbivorous urchin *Diadema* spp. show a much more barren bottom surrounding the cement-bag pile. Before 1983, the crevices between bags were densely populated by *Diadema* spp. *Diadema* are herbivores that range into the open at night to graze on algae.

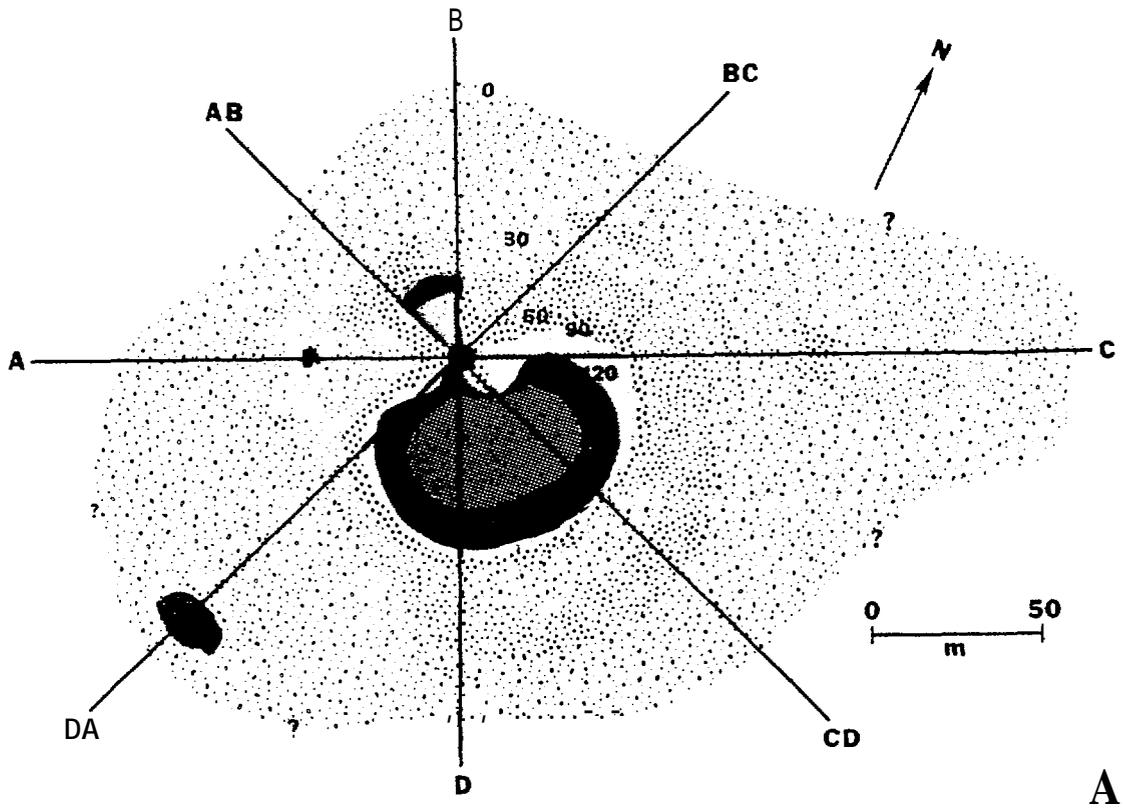
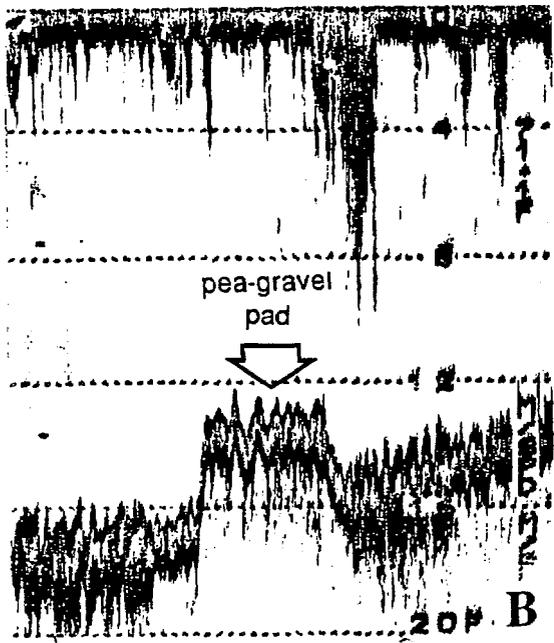
Figure 6. (A) Pea gravel and/or sediment thickness determined from probings taken along radial-transect lines. Thickness in centimeters. Area near center is >150 cm. Small bullseye to south of site is a local sediment-filled bedrock depression. (B) Fathometer profile crossing bag pile and pea-gravel pad from northwest to southeast. Note slope of bedrock from gravel pile is relatively flat at 4.5 m (15 ft). Add 0.6 m (2 ft) to values on profile to obtain true depth. Profile was made at low tide.

Probing was conducted at site **SL 1011** Nos. 2 and 3 to determine a possible relation between grass communities and substrate. The gravel pile was probed every 5 m (16 ft) along each radial transect line using a 1.5-m (5 ft) stainless steel shaft driven with a mallet. In areas away from the epicenter, where changes in sediment thickness were less frequent, probes were made every 10 m. Over 400 probes were made. Gravel and sediment thicknesses (the accumulation is underlain by relatively hard limestone) were recorded to the nearest centimeter. These data allowed the construction of a gravel thickness or **isopach** map (Fig, 6A).

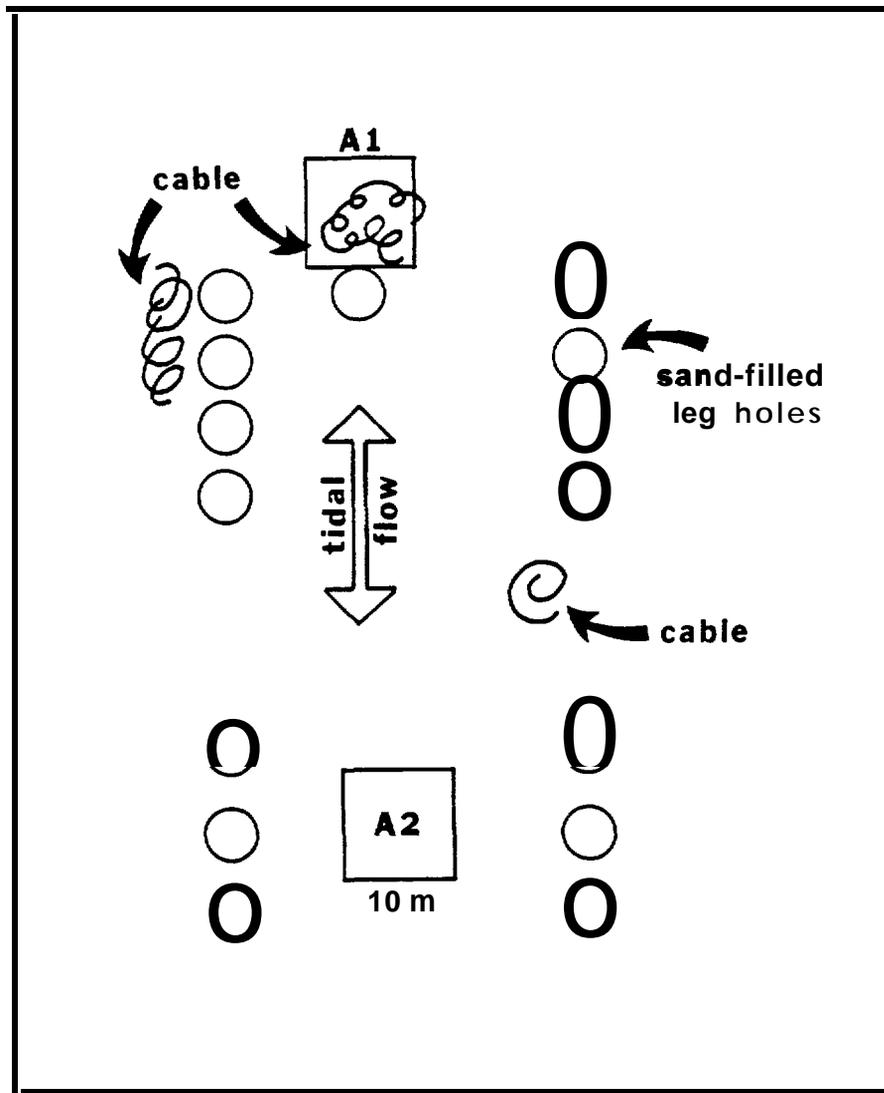
Figure 9. Map of site OCS 0665 No. 1 showing location of quadrats, tidal-flow direction, and distribution of debris, which consists mainly of discarded cable. Quadrat A-1 is situated down-current and adjacent to sand hole around well bore and includes cable debris. A-2 is situated downcurrent and beneath the platform, where organisms would be subject to both drill effluents and shade. Bottom is flat. There is no cable debris in A-2.

Mechanical damage at site OCS 0665 No. 1 is clearly recognizable and easily measured (Figs. 8, 9, 10A, E). The 15 circular sand-filled depressions, each 4.56 m (15 ft) in diameter, amount to a total of 242 m<sup>2</sup> (2,600 ft<sup>2</sup>), and the two scars total 164 m<sup>2</sup> (1,765 ft<sup>2</sup>), making a grand total of 406 m<sup>2</sup> (4,365 ft<sup>2</sup>), or approximately 10% of an acre that has not **been recolonized by coral and gorgonian growth in the past 28 years.** Based on the average number of corals and **gorgonians** in both control areas, each of which is 100 m<sup>2</sup>, we calculate that **520 coral colonies and 2,738 gorgonians** were killed in the 406-m<sup>2</sup> area of the sand-filled footprints and anchor scars. Eventually, corals may colonize the depressions, but when that might **occur is impossible to determine.** In an area of vigorous coral growth, recolonization would occur faster than at site OCS 0665 No. 1, which, as discussed earlier, is one of marginal growth punctuated sporadically by widespread mortality.

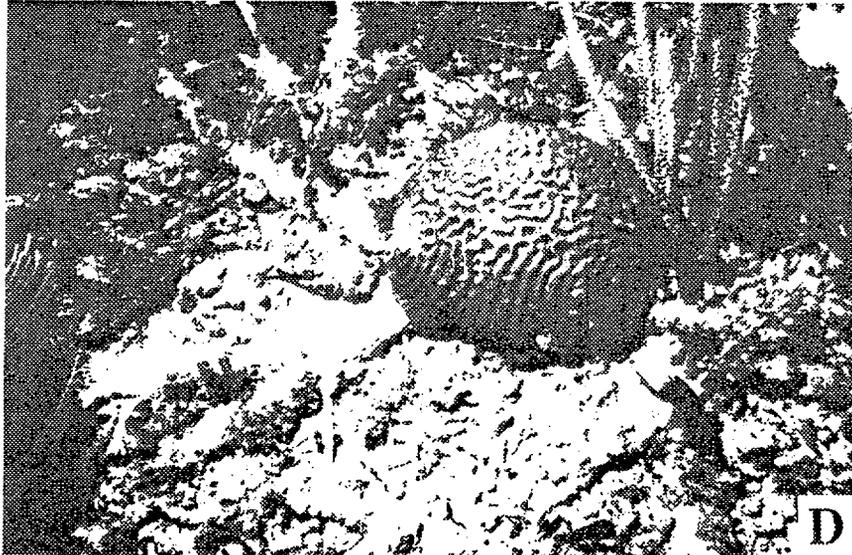
Figure 10 (continued). (D) **B**rain coral growing on intersection of two pieces of cable within quadrat A-1. (E) Large basket sponge growing on cable debris in quadrat A-1. View is toward circular sand hole, where well bore is buried. Vertical black line attached to piece of cable is tied to marker buoy.

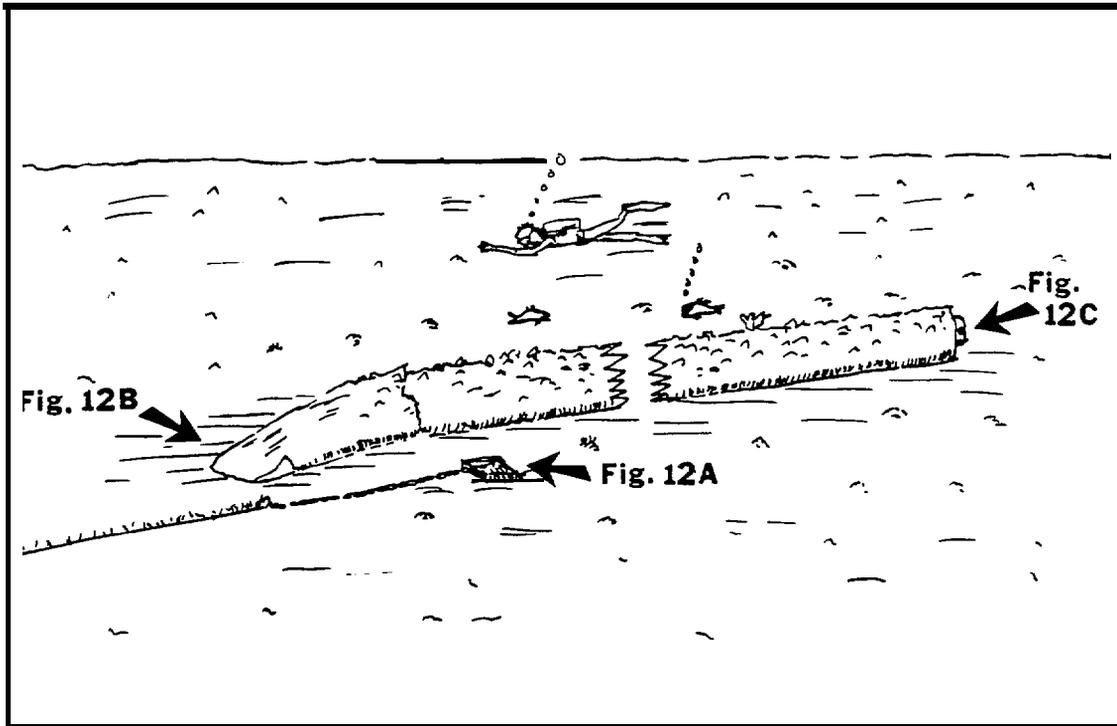
Figure 11. Sketch of 23-m-long (77 ft) conductor pipe casing at site OCS 0674. Well bore is at left, where pipe bends into bottom. Angles of view of underwater photographs in following figure are indicated by directions of arrows. Clumps of brown fleshy algae litter the surrounding sandy bottom.

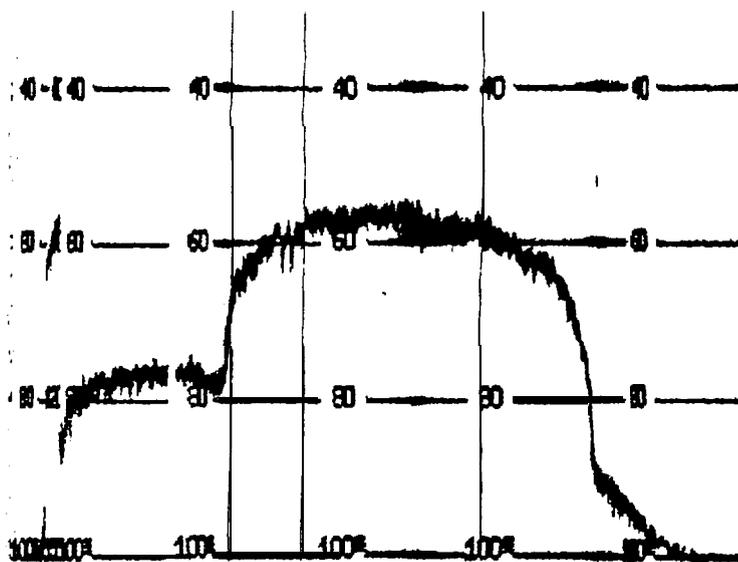
Figure 14. North-south fathometer profile across coral knoll, where well OCS 0672 No. 1 was drilled at shallowest point (20 m, or 65 ft). Knoll is surrounded by sandy bottom similar to that at site OCS 0674.

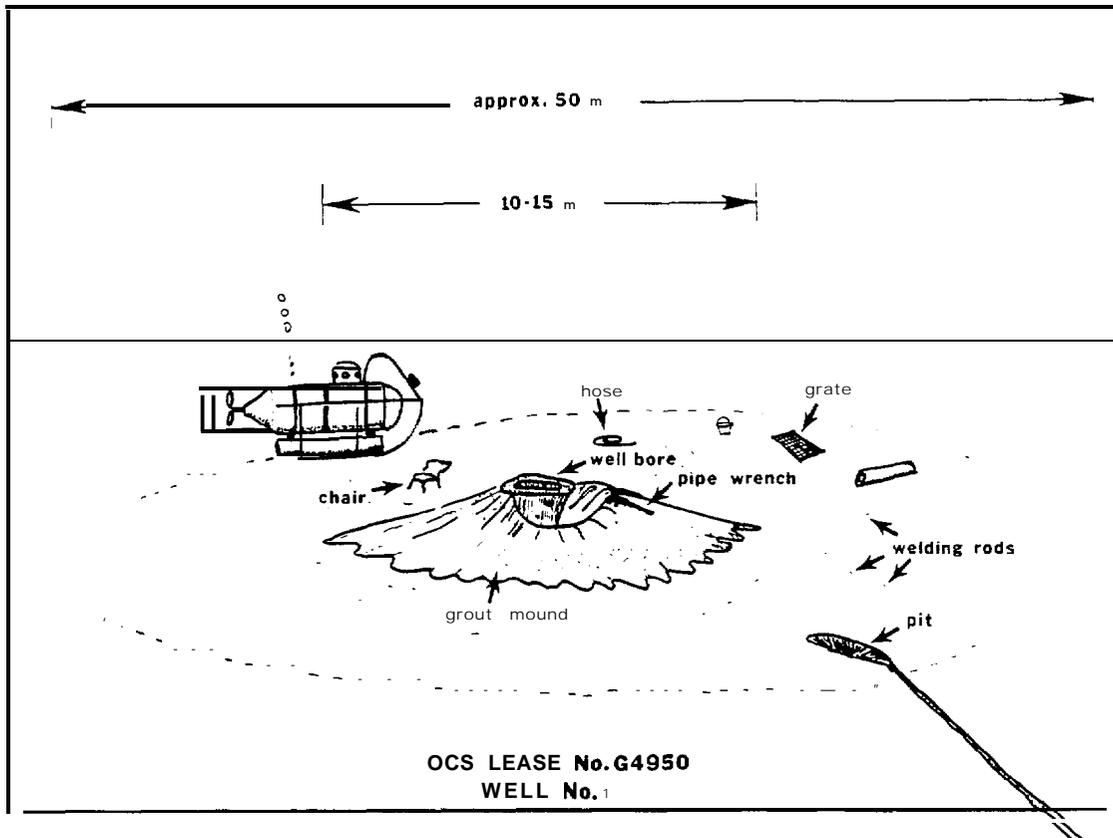
Figure 18. Sketch of well site OCS G4950 showing approximate position of various debris objects. Pipe to right is one shown in Figure 16C. Long furrow leads from 60-cm-deep (2 ft) pit at lower right. Dotted line shows approximate limit of zone of visual disturbance. Water depth is 70 m (230 ft).

The algal/sponge community, like that shown in Figure 17A and B, was covered by the cement donut and grout pile. The diameter of the covered area is estimated to be 10 to 15 m (33-50 ft). The natural community surrounding the mound was less dense than 25 m (82 ft) away from the mound. The area of visual disturbance extended radially approximately 25 m from the grout mound. Beyond 25 m and as far away as at least 200 m (656 ft), the bottom community appeared the same and looked much like that in Figure 17A. Organisms partially blanketed by sediment or drill mud were not observed, even within the disturbed area close to the grout mound. The total area visually affected was approximately 50 m in diameter. Within the 50-m-diameter area, the bottom community was completely obliterated only in the 10- to 15-m-diameter area of the central grout mound. The debris mentioned earlier was scattered within the 50-m-diameter area affected as depicted in Figure 18.
